# Bridge Construction Impacts the Adjacent Channel Morphology and Turbidity: A Study on a Dying Distributary of River Padma

**Keywords:** bridge engineering, channel geomorphology, habitat of dying river, Jalangi river, river-road crossing

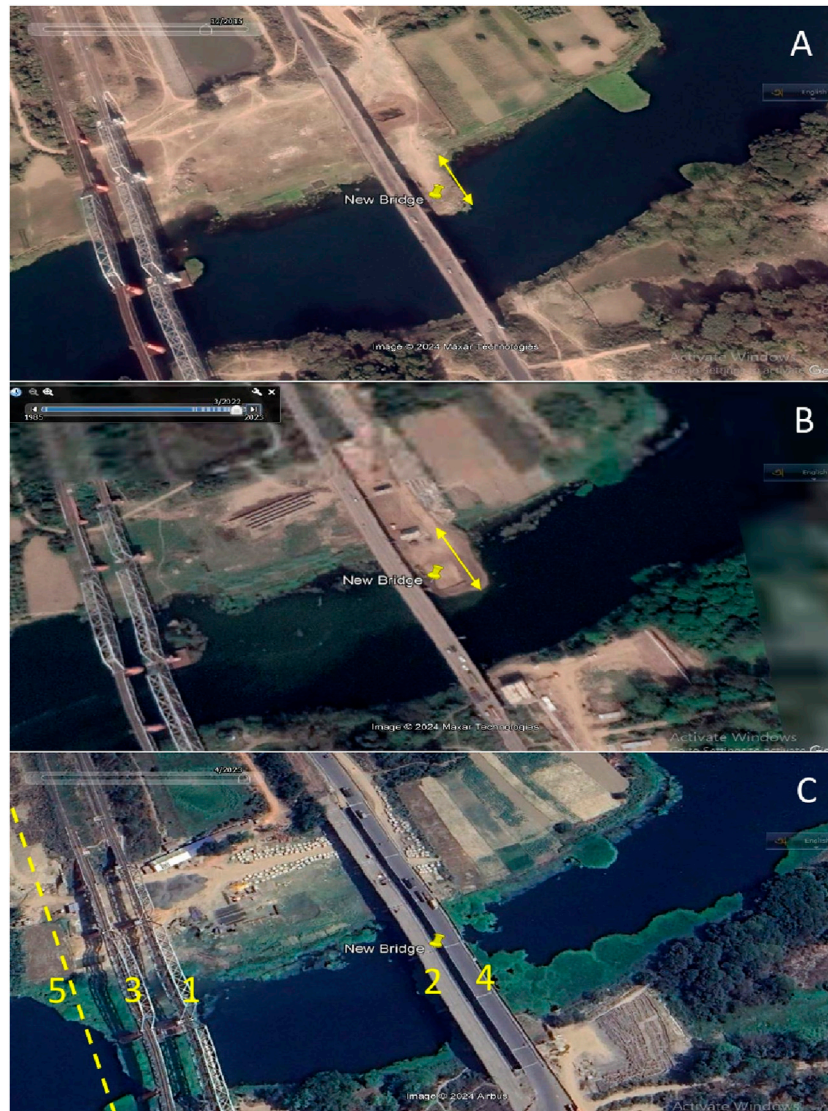
**FIGURE 2** | Google Earth Pro images showing different phases of bridge constructions and interference with the channel morphology. **(A)** Image of December 2015 showing soil filling within the channel from the right bank. **(B)** Image of March 2022 showing soil filling within the channel from the right bank and diases at the base of the pier are constructed. **(C)** Image of April 2023 completion of the bridge. Numbers from 1 to 5 written in yellow represents the sequences of bridges on the river (2 and 4 are highway bridges and 1, 3 and 5 are railway bridges).

Using dumpy level, and accessories we measured width ( $w$ ), average depth ( $\bar{d}$ ), wetted perimeter ( $P_w$ ), and cross-sectional area ( $A$ ) at 3 sites of the river Jalangi, one at upstream, 2nd at downstream and 3rd at the bridge site. From those data on cross-sections, we calculated the width/depth ratio ( $\bar{w}/\bar{d}$ ), hydraulic radius ( $R_h$ ), and maximum depth ( $d_{max}$ ) of those stations. Using auto-level, dumpy level, and accessories we also estimated the volume of soil put into the river bed to facilitate the construction processes of the bridge (**Figure 2**).

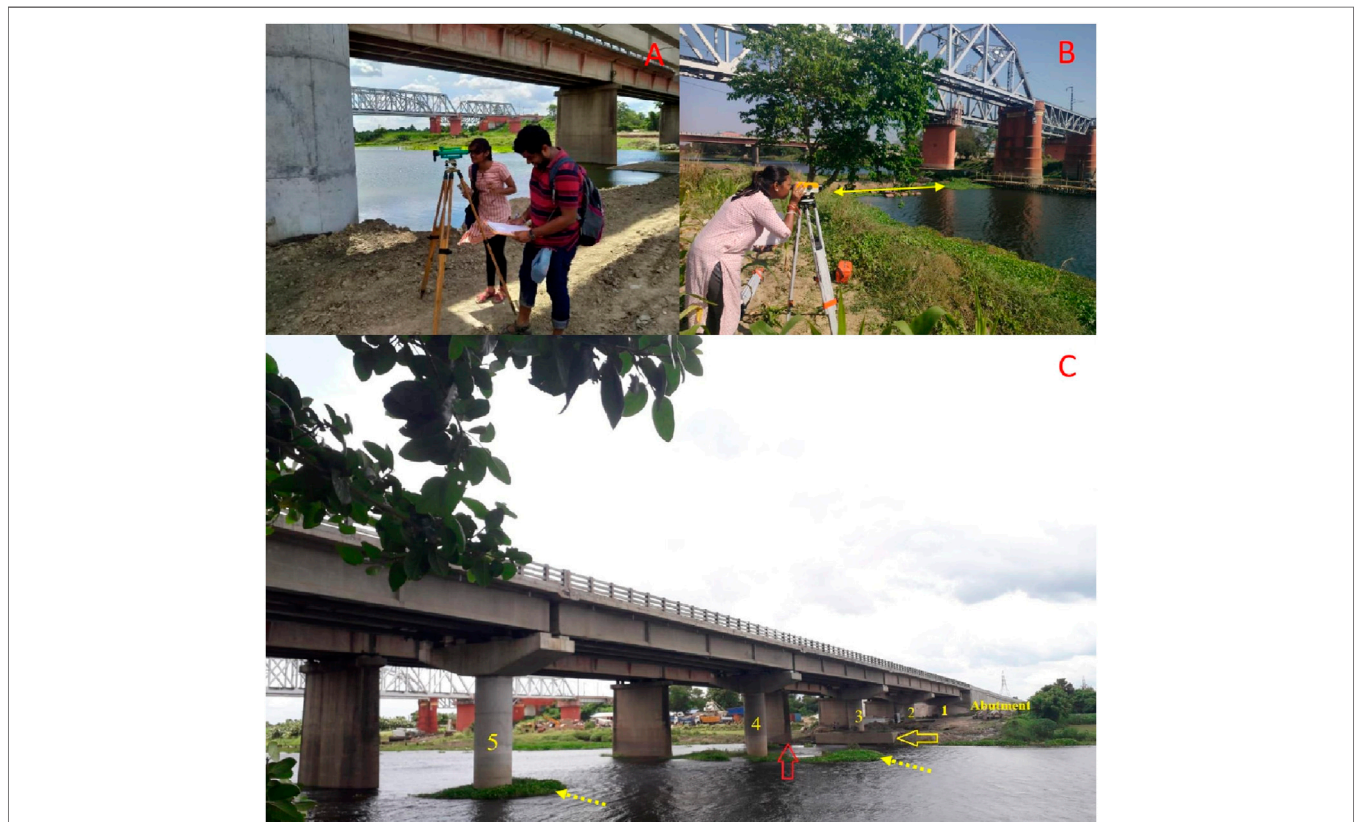
**FIGURE 3** | (A) The volume of soil fill for facilitating construction processes is being estimated by Shrabani Das (co-author) and her classmate. (B) The cross-sectional morphology of the channel downstream of the 3rd railway bridge is being measured. (C) A wide yellow arrow points towards the right bank, showing a dike well above the water level of the channel as of 20.07.2024. Notably, the earth-filling from the bank to the dike has partially closed the channel. The red wide arrow points to the pier without a dike of the old bridge and the flow surrounding the pier. Dotted yellow arrows indicate the hyacinths stuck to the dikes at the base of the piers of the new bridge.

The construction processes of the “New Bridge” created a great impact on channel morphology within a short period of 5 years (2017-2023). For bridge construction, an earthen basement of 34 m wide was made and the river bed was filled with soil first on the right bank side and then on the left bank side (**Table 4; Figure 3**).

For the construction of the New Bridge, a total of  $23,653 \text{ m}^3$  of soil was deposited into the river. In the initial phase of construction, surveyed in March 2022, the soil was placed on the right bank. On 09.03.2022, it was observed that the in-bed soil filling on the right side increased the asymmetry of the hydraulic geometry of the flowing channel by 1.56 times ( $A^* = -0.28$ ). Comparing this to the channel geometry of the previous channel in 2017, the  $A^*$  was  $-0.97$ . In July 2022, the river flow was directed along the right bank. During the second phase, surveyed on July 15, 2022, after a four-month interval, the hydraulic geometry of the flowing channel exhibited positive asymmetry ( $A^* = 0.18$ ). Considering channel geometry, the  $A^*$  value was 0.81 on 15th July 2022. During this phase, construction of the pier along the left bank was underway, involving the deposition of  $20,758 \text{ m}^3$  of soil

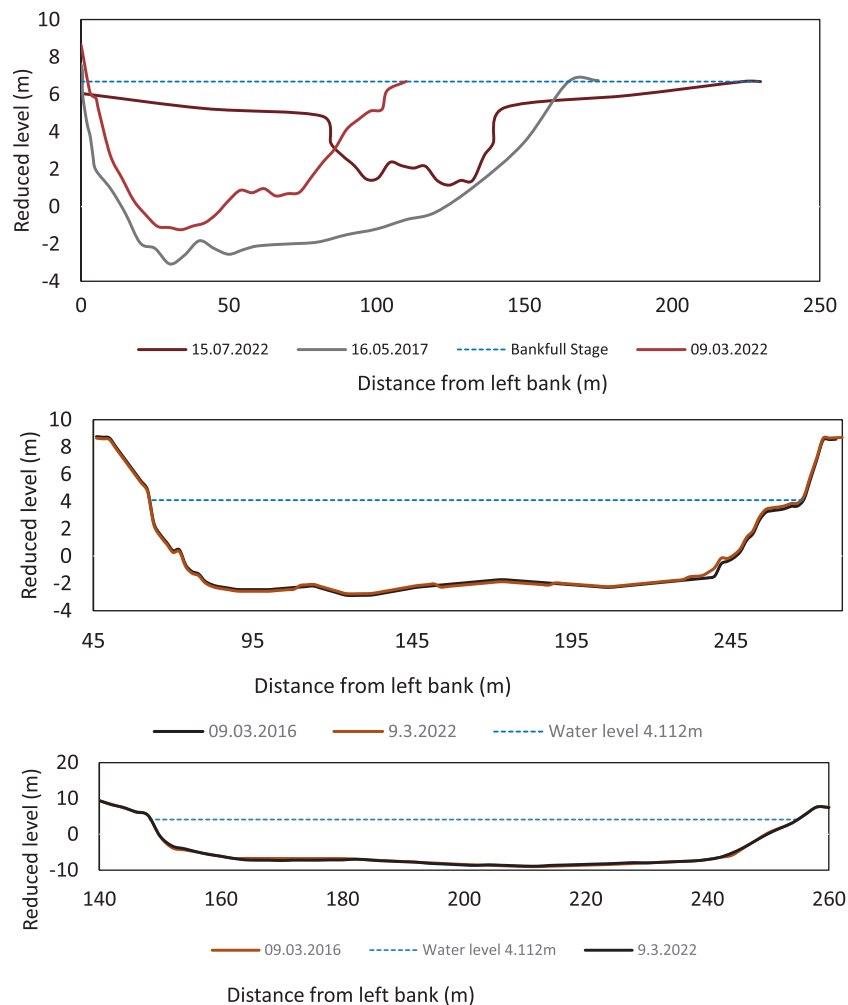
**FIGURE 4** | Temporal Changes in cross-sectional profiles of the river Jalangi. **(A)** Soil fill for the construction process and changes in the cross-sectional form of the channel at the construction site. **(B)** Temporal Changes in cross-sectional profiles 100 m upstream of the New bridge of the river Jalangi. Riverbed levels on two different dates: March 9, 2016 (in black) and March 9, 2022 (in brown). **(C)** Temporal Changes in cross-sectional profiles 400 m downstream of the New bridge of the river Jalangi. The figure compares the riverbed levels on two different dates: March 9, 2016 (in brown) and March 9, 2022 (in black).

Due to the soil filling aimed at facilitating construction, over half of the channel width was alternately closed on both sides, resulting in a significant change in the cross-sectional profile of the river (**Figure 4A**). In 2017, the construction of the New Highway Bridge began involving the putting of soil for the approach road to the pier site. At that time, the cross-sectional area of the channel was measured at  $1,139.13 \text{ m}^2$ . During that period the channel was negatively asymmetric ( $A^* = -0.18$ ) meaning the main flow was along the left bank. Soil filling process also narrowed down the channel.

The **Figure 4B** shows the cross-sectional profile of the river at a location 100 m upstream from the bridge site. It compares the riverbed levels on two different dates: March 9, 2016 (in black) and March 9, 2022 (in brown). The water level is marked at 4.112 m with a blue dashed line (9.3.2022). The cross-sectional profiles from both dates are very similar, indicating minimal change in the riverbed’s shape over the 6 years.  $A^*$  calculated for both the dates are  $-0.037$  and  $-0.033$  respectively. These suggest that the bridge construction might not have significantly altered the overall form of the river cross-section at this location.

A cross-sectional measurement taken 400 m downstream of the bridge revealed no significant difference between the pre-and post-bridge forms of the channel (**Figure 4C**). It compares the riverbed levels on two different dates: March 9, 2016 (in brown) and March 9, 2022 (in black). The water level is marked at 4.112 m with a blue dashed line (9.3.2022). The cross-sectional profiles from both dates are very similar, indicating the minimal change in the riverbed’s shape over the 6 years.  $A^*$  calculated for both the dates are  $-0.0255$  and  $-0.0257$  respectively. Lagasse et al. (2012)

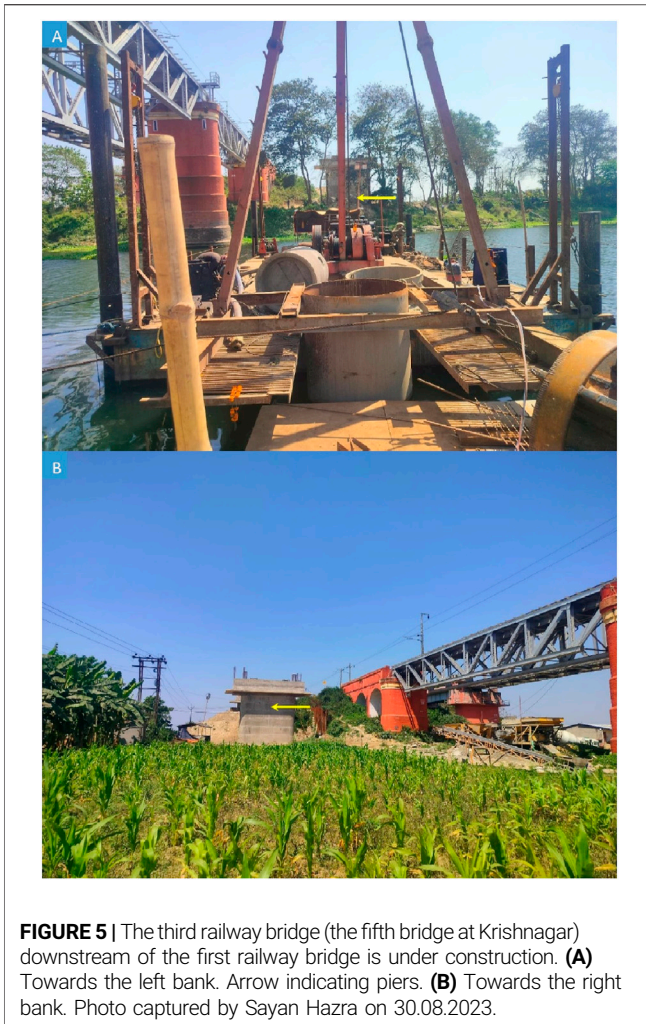
**FIGURE 5** | The third railway bridge (the fifth bridge at Krishnagar) downstream of the first railway bridge is under construction. **(A)** Towards the left bank. Arrow indicating piers. **(B)** Towards the right bank. Photo captured by Sayan Hazra on 30.08.2023.

It is strongly recommended to ensure that the base of the bridge piers is not made on dias. The presence of dias at the base of piers can pose a serious obstacle within the channel (Das, 2019), affecting both the natural flow of the river and the movement of aquatic organisms (Wang et al., 2023). However, the third railway bridge (**Figure 5**), which has been under construction since 2023, is also designed to include a dias at the base of the piers.

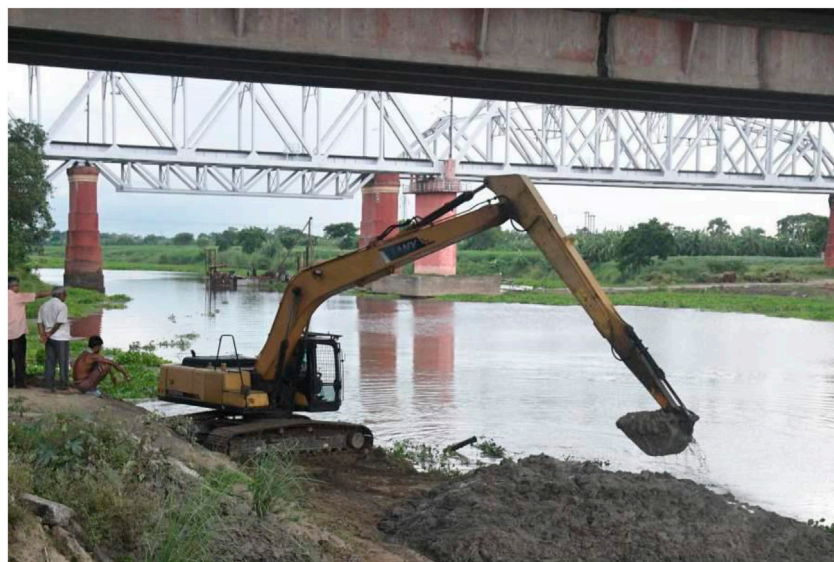
**FIGURE 6** | Post-construction removal of soil and debris from the river bed and banks by NHA. (Curtsey: The Telegraph Online, 02.07.2024).

Earth or soil placed in the river during construction to facilitate the building process should be diligently removed once construction is completed. Leaving construction debris in the river can have adverse effects on water flow (Das, 2019), sedimentation, and overall river health. Responsible disposal practices should be employed to minimize environmental impact. The negligence of removing construction debris from the Jalangi River by the construction agency was brought to the attention of the National Highway Authority of India (NHA) by “Save Jalangi,” and other activist groups. As a result of this initiative, in June 2024, KCC BildconPvt. Limited removed earth and concrete slabs from the riverbed and banks (**Figure 6**).

obstructed by the dumping of concrete slabs and soil. After repeated petitions by various environmental activist groups, the soil and debris were finally cleared from the riverbed and the area around the abutments in June 2024 (**Figure 6**). This obstruction is likely a short-term issue. However, it could have had long-term impacts, as seen with the railway bridge. These potential long-term impacts were avoided because environmental activists persistently pressured the authorities.
